DEPARTMENT OF TRANSPORTATION**DIVISION OF ENGINEERING SERVICES**

Contract #: 04-0120F4Cty: SF/ALA Rte: 80 PM: 13.2/13.9File #: 69.28**WELDING INSPECTION REPORT****Resident Engineer:**Pursell, Gary**Address:** 333 Burma Road**City:** Oakland, CA 94607**Report No:** WIR-003965**Date Inspected:** 10-Sep-2008**Project Name:** SAS Superstructure**OSM Arrival Time:** 700**Prime Contractor:** American Bridge/Fluor Enterprises, a JV**OSM Departure Time:** 1530**Contractor:** Zhenhua Port Machinery Company, Ltd (ZPMC), Changxing Island **Location:** Shanghai, China**CWI Name:** Wu Ming Kai**CWI Present:** Yes No**Inspected CWI report:** Yes No N/A**Rod Oven in Use:** Yes No N/A**Electrode to specification:** Yes No N/A**Weld Procedures Followed:** Yes No N/A**Qualified Welders:** Yes No N/A**Verified Joint Fit-up:** Yes No N/A**Approved Drawings:** Yes No N/A**Approved WPS:** Yes No N/A**Delayed / Cancelled:** Yes No N/A**Bridge No:** 34-0006**Component:** Tower**Summary of Items Observed:**

OBG Bay 4:

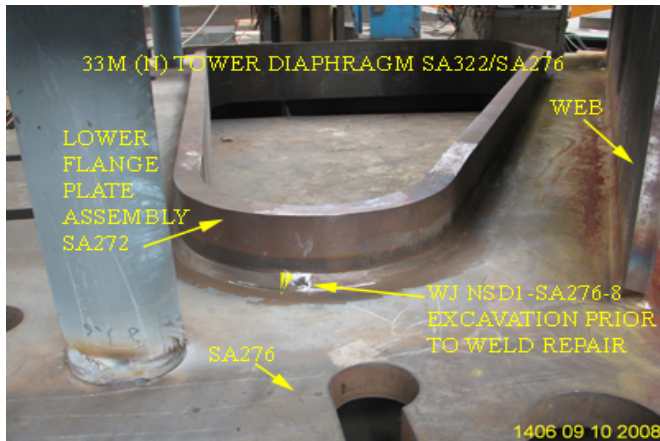
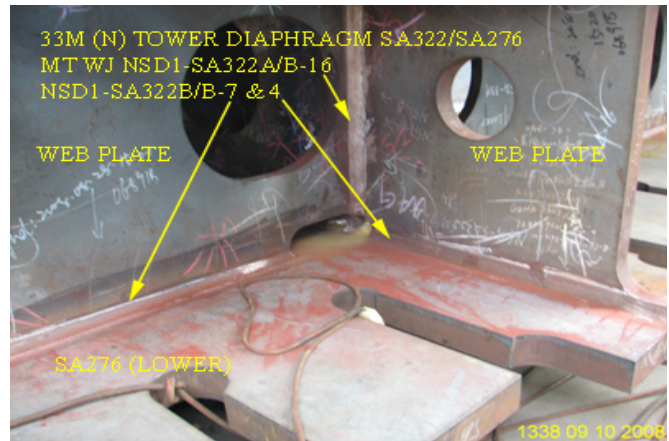
The QA Inspector was requested by ZPMC QC, to observe Magnetic Particle Testing (MT) of all welds on 33M North Tower Diaphragm Assembly SA322/SA276. The QA Inspector randomly observed ZPMC Non-Destructive Testing (NDT) Technician Cai Xin Xin utilizing the MT Method to examine 100% of the cover pass of the welds attaching the web plates to 33M North Top Tower Diaphragm SA322 at Weld Joint (WJ) Numbers NSD1-SA322B/B-3, 4, 7, 8, 11, 12, 15 and 16; and the web to web WJ's on 33M North Tower Diaphragm SA322/276. There were 5 initial indications found which were removed by grinding. Those areas were again examined with MT by Mr. Cai. Upon re-examination with MT by Mr. Cai, all the above listed welds appeared to have no indications and were accepted. The welds attaching the web plates to the upper Tower Diaphragm SA322 and the welds attaching Flange Plate Assemblies SA272 and SA275 to the 33M top and bottom tower diaphragms were not examined at this time. The QA Inspector randomly observed that a repair needed to be performed in the fillet weld attaching Flange Plate Assembly SA275 to 33M Bottom Tower Diaphragm SA276, WJ NSD1-SA276-8. The attached photographs provide additional detail.

The QA Inspector randomly performed a 10% MT final verification of the cover pass of the welds attaching the web plates to 33M North Top Tower Diaphragm SA322 at Weld Joint (WJ) Numbers NSD1-SA322B/B-3, 4, 7, 8, 11, 12, 15 and 16; and the web to web WJ's on 33M North Tower Diaphragm SA322/276. There appeared to be

no indications and the QA Inspector accepted the above listed welds. See TL 6028 for this date for additional detail.
